TAMU Project

**Energy Consumption Data Quality Assurance/Quality
Control Assessment Report for the
Month of November 2017**

**Utility & Energy Services
Division of Administration
Texas A&M University**

December 2017

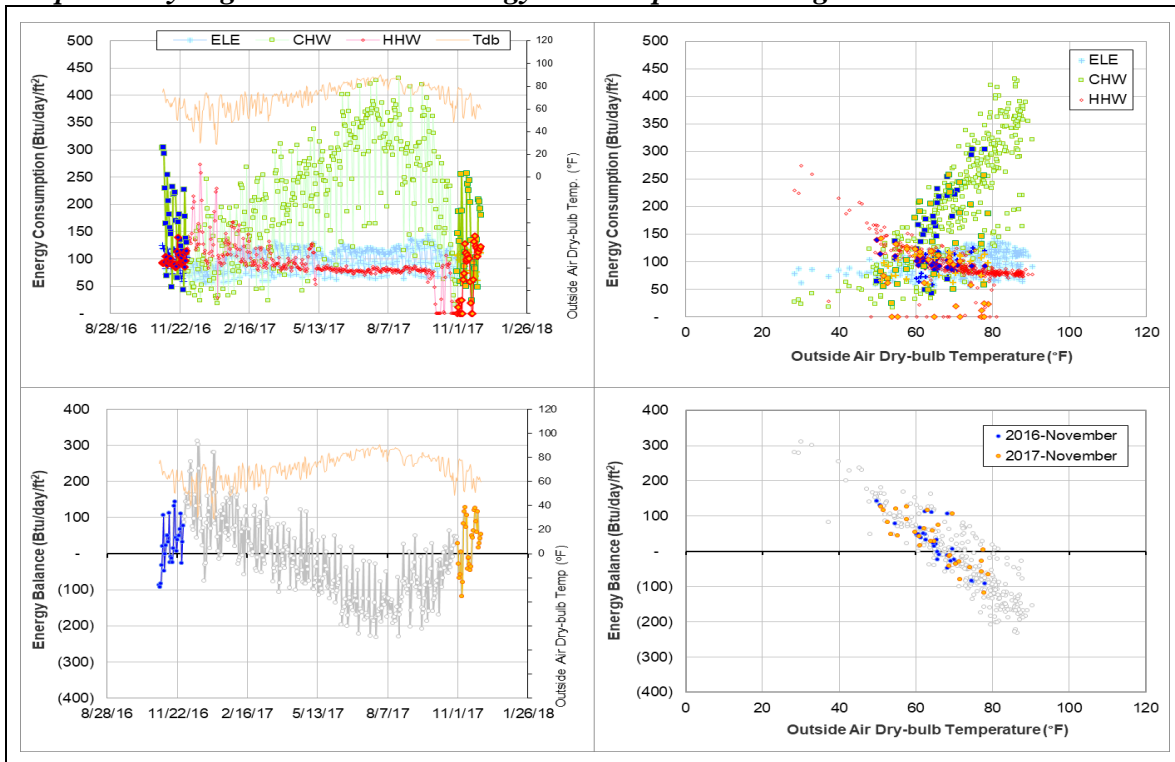
The HHW consumption decreased to zero during two different periods in November, similar as October. This decrease appears to be related to the flow rate reducing to zero. The HHW consumption for these periods was estimated by model.

Explanatory Figure: 13 months energy balance plot with original data

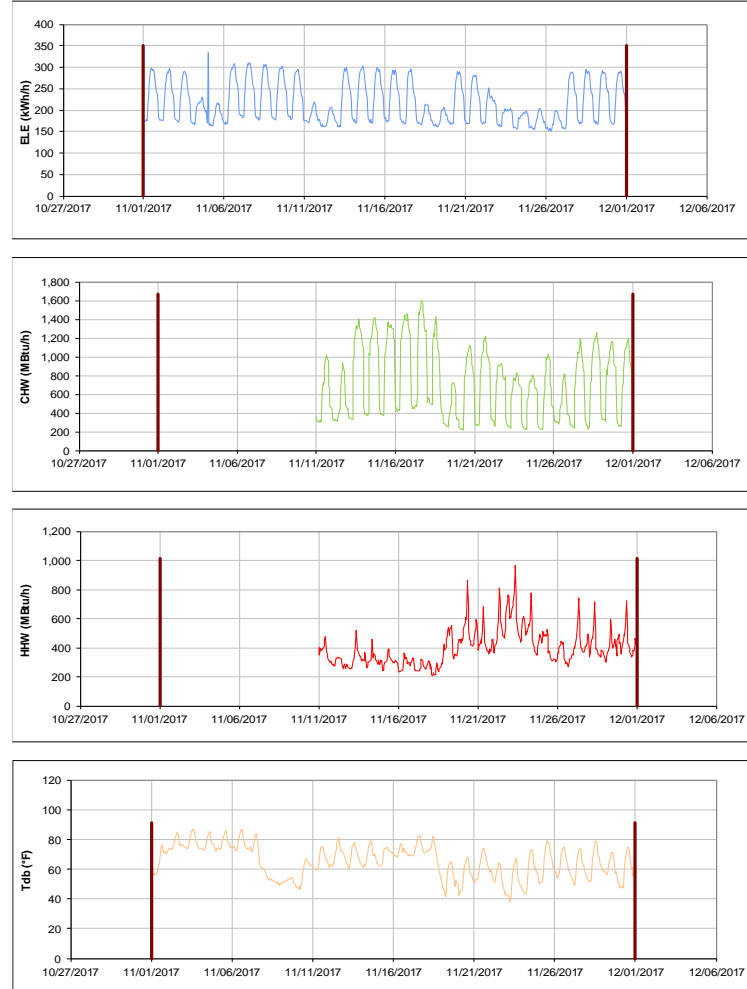
TAMU / BLDG #: 1325-0385

Figure III-9 Hourly Whole Building Electricity, Chilled Water, and Hot Water Consumption for CE TTI Office & Lab Building during the Month of November 2017 and the Corresponding Hourly Outdoor Dry Bulb Temperature for College Station, TX

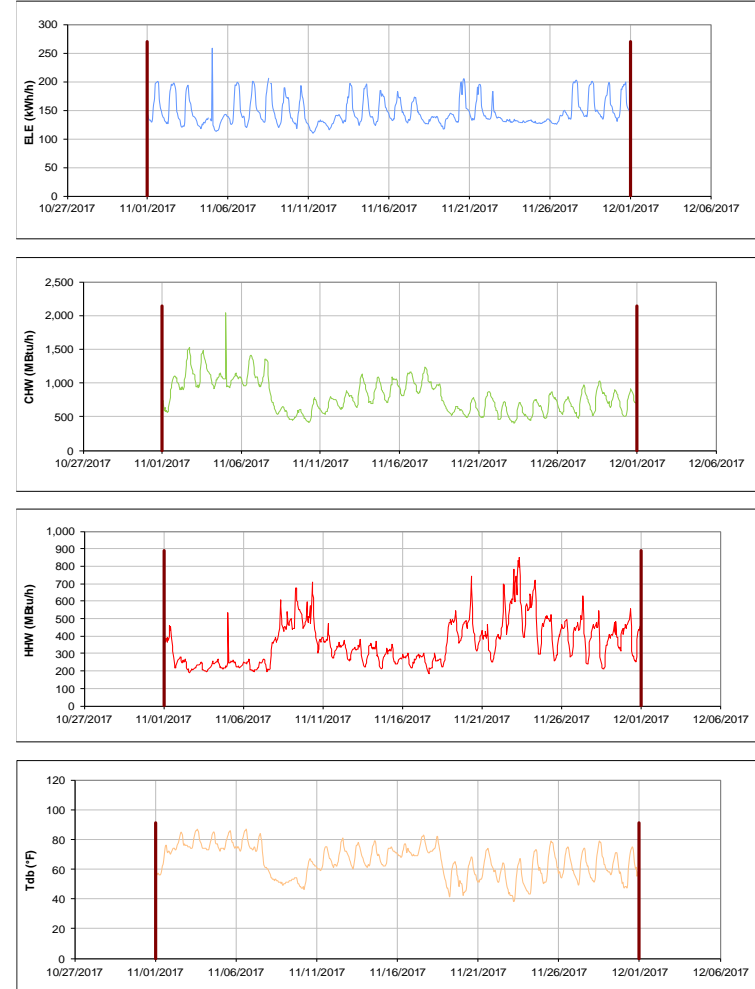
Architecture Building B&C TAMU / BLDG #: 1359-0432

Figure III-12 Hourly Whole Building Electricity, Chilled Water, and Hot Water Consumption for Architecture Building B&C during the Month of November 2017 and the Corresponding Hourly Outdoor Dry Bulb Temperature for College Station, TX

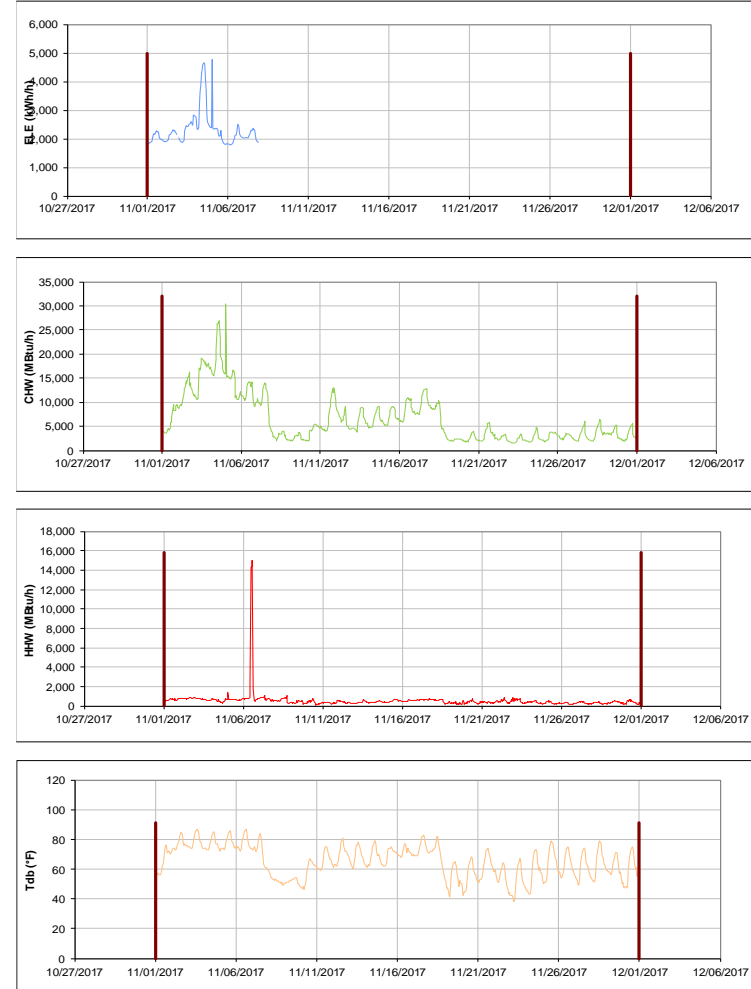
TAMU / BLDG #: 0367

Figure III-16 Hourly Whole Building Electricity, Chilled Water, and Hot Water Consumption for Kyle Field during the Month of November 2017 and the Corresponding Hourly Outdoor Dry Bulb Temperature for College Station, TX

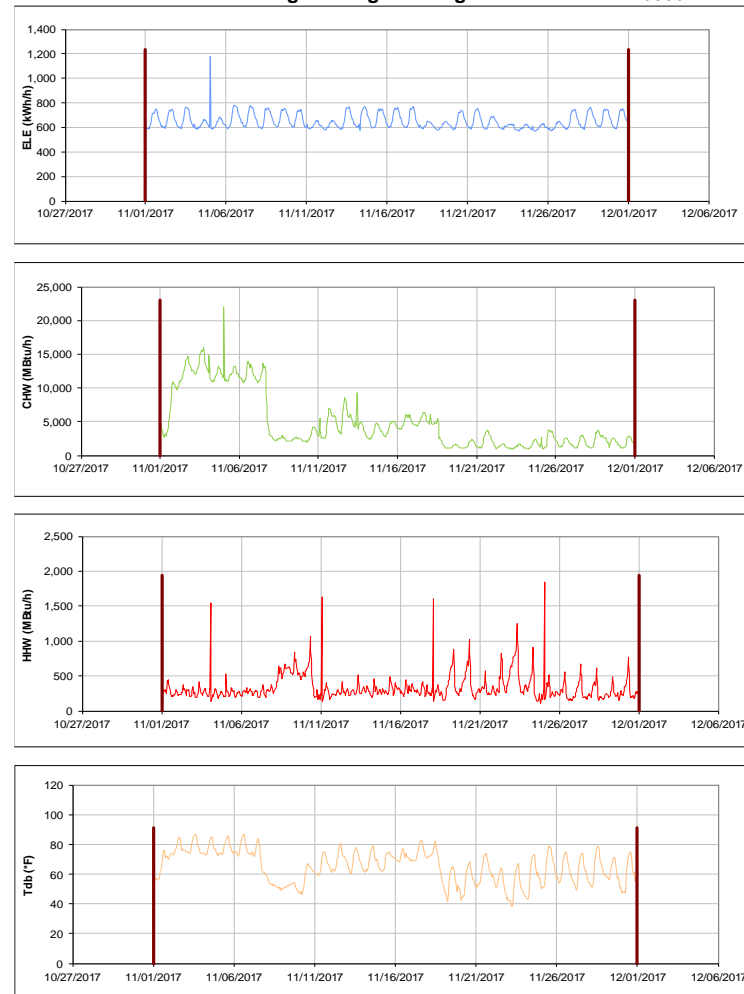
TAMU / BLDG #: 0386

Figure III-20 Hourly Whole Building Electricity, Chilled Water, and Hot Water Consumption for Jack E. Brown Chemical Engineering Building during the Month of November 2017 and the Corresponding Hourly Outdoor Dry Bulb Temperature for College Station, TX

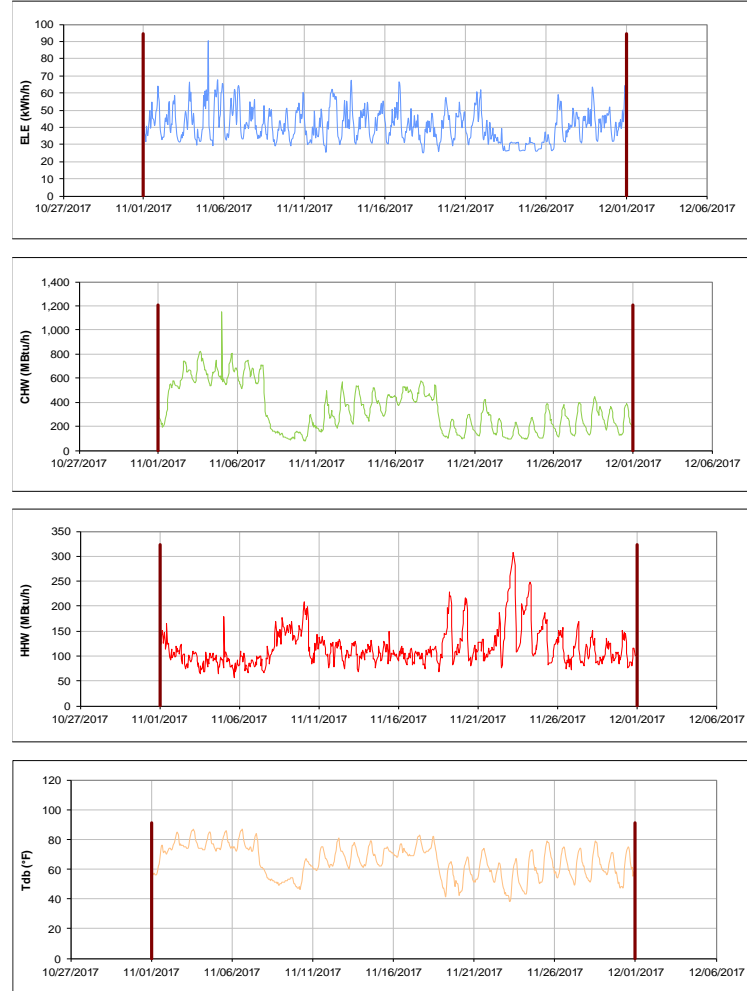
TAMU / BLDG #: 0402

Figure III-27 Hourly Whole Building Electricity, Chilled Water, and Hot Water Consumption for Briggs Hall Dorm 3 during the Month of November 2017 and the Corresponding Hourly Outdoor Dry Bulb Temperature for College Station, TX

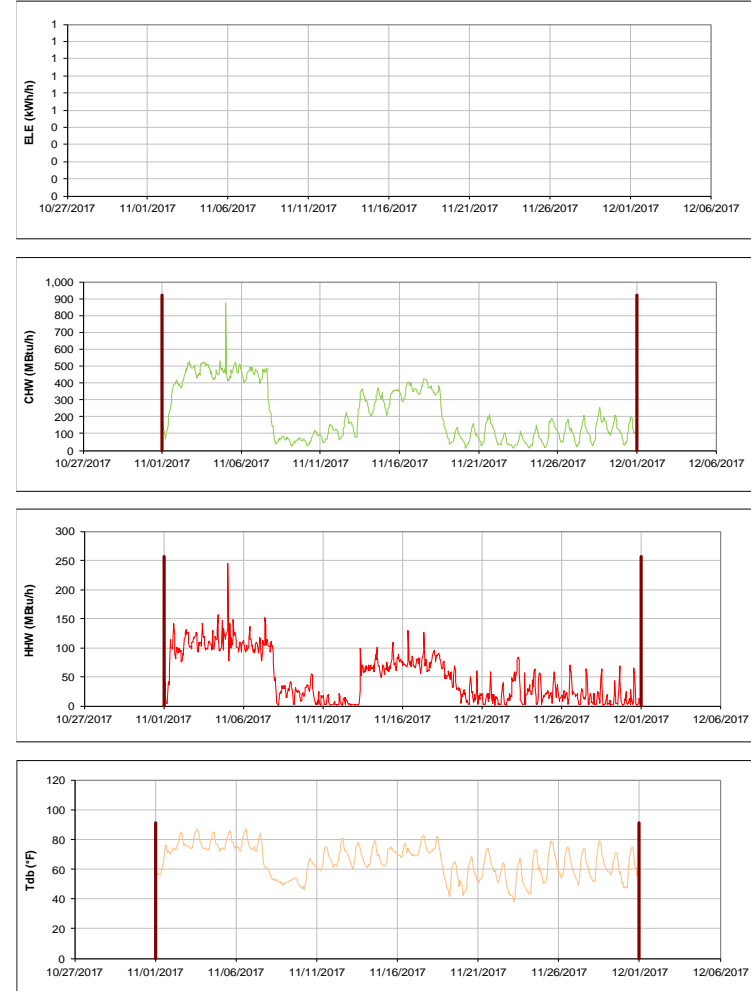
TAMU / BLDG #: 1405

Figure III-28 Hourly Whole Building Electricity, Chilled Water, and Hot Water Consumption for Ash II LLC during the Month of November 2017 and the Corresponding Hourly Outdoor Dry Bulb Temperature for College Station, TX

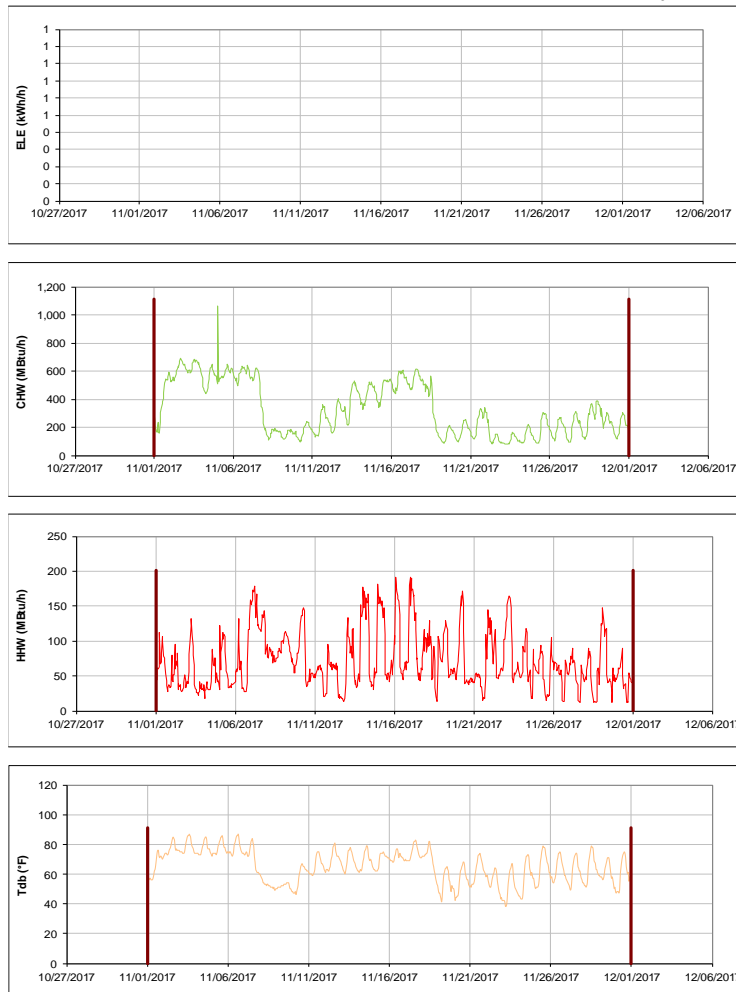
TAMU / BLDG #: 1404

Figure III-32 Hourly Whole Building Electricity, Chilled Water, and Hot Water Consumption for Plank LLC during the Month of November 2017 and the Corresponding Hourly Outdoor Dry Bulb Temperature for College Station, TX

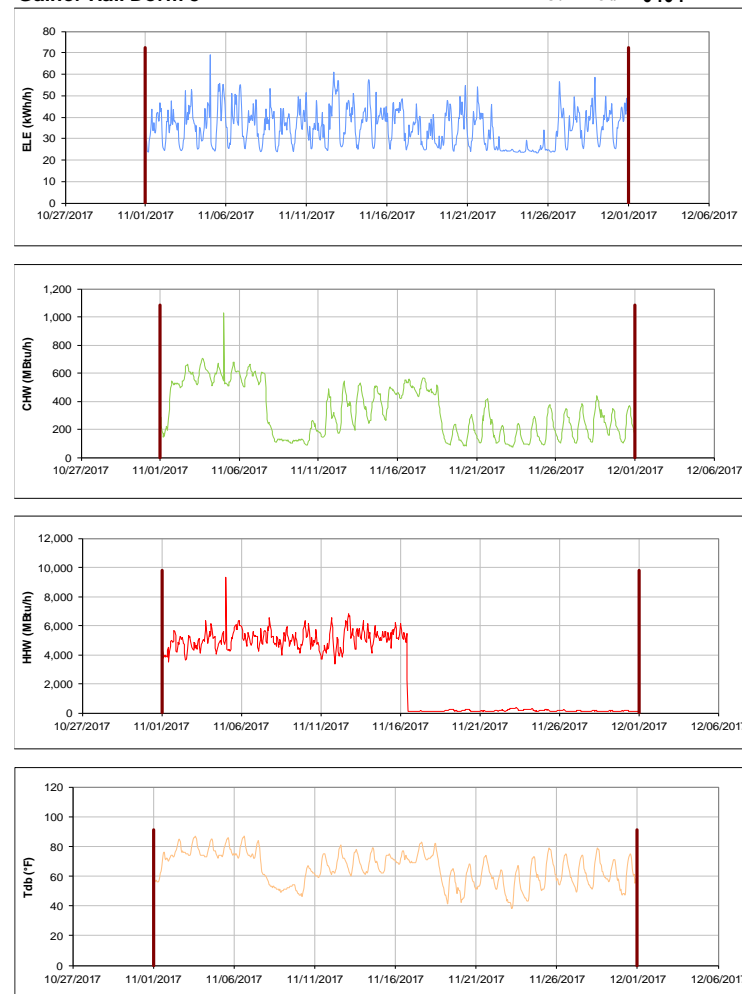
TAMU / BLDG #: 0404

Figure III-34 Hourly Whole Building Electricity, Chilled Water, and Hot Water Consumption for Gainer Hall Dorm 5 during the Month of November 2017 and the Corresponding Hourly Outdoor Dry Bulb Temperature for College Station, TX

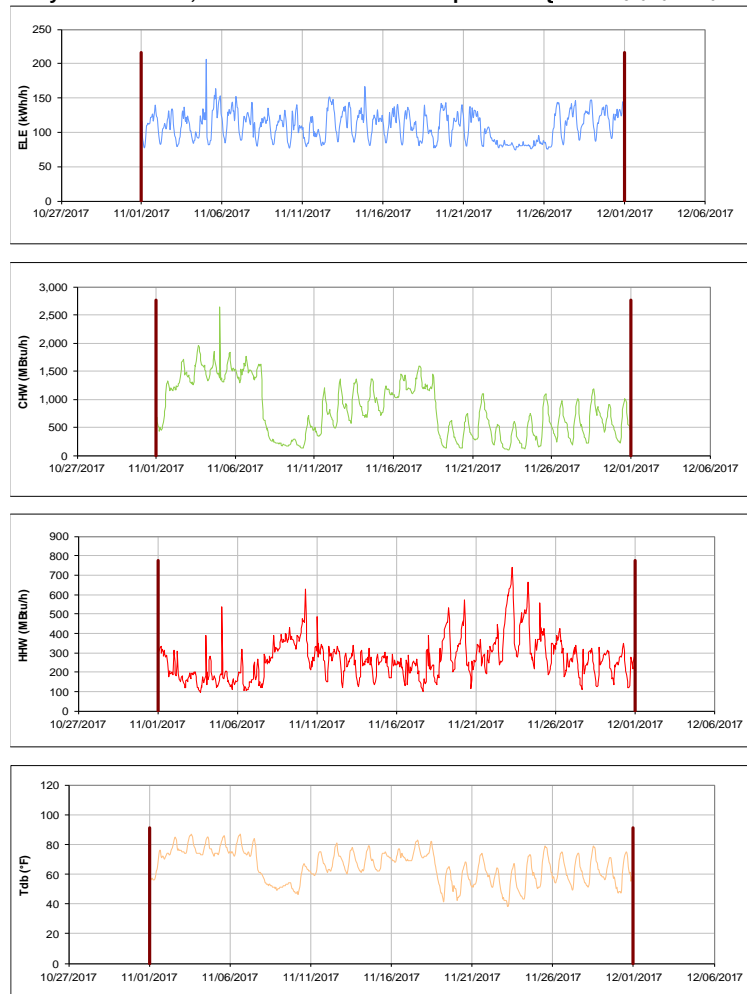
Lacy Hall - Dorm 6, Harrell Hall and Leadership Learning Center / BLDG #: 5-0407-1402

Figure III-37 Hourly Whole Building Electricity, Chilled Water, and Hot Water Consumption for Lacy Hall - Dorm 6, Harrell Hall and Leadership Learning Center during the Month of November 2017 and the Corresponding Hourly Outdoor Dry Bulb Temperature for College Station, TX

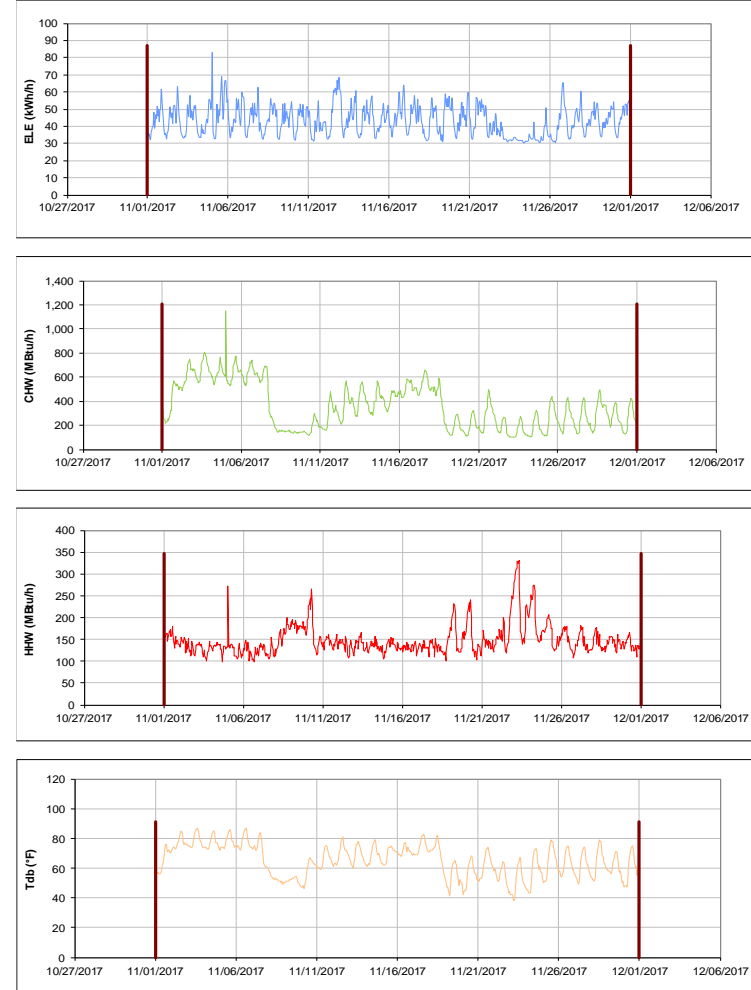
TAMU / BLDG #: 0409

Figure III-42 Hourly Whole Building Electricity, Chilled Water, and Hot Water Consumption for White Hall - Dorm 10 during the Month of November 2017 and the Corresponding Hourly Outdoor Dry Bulb Temperature for College Station, TX

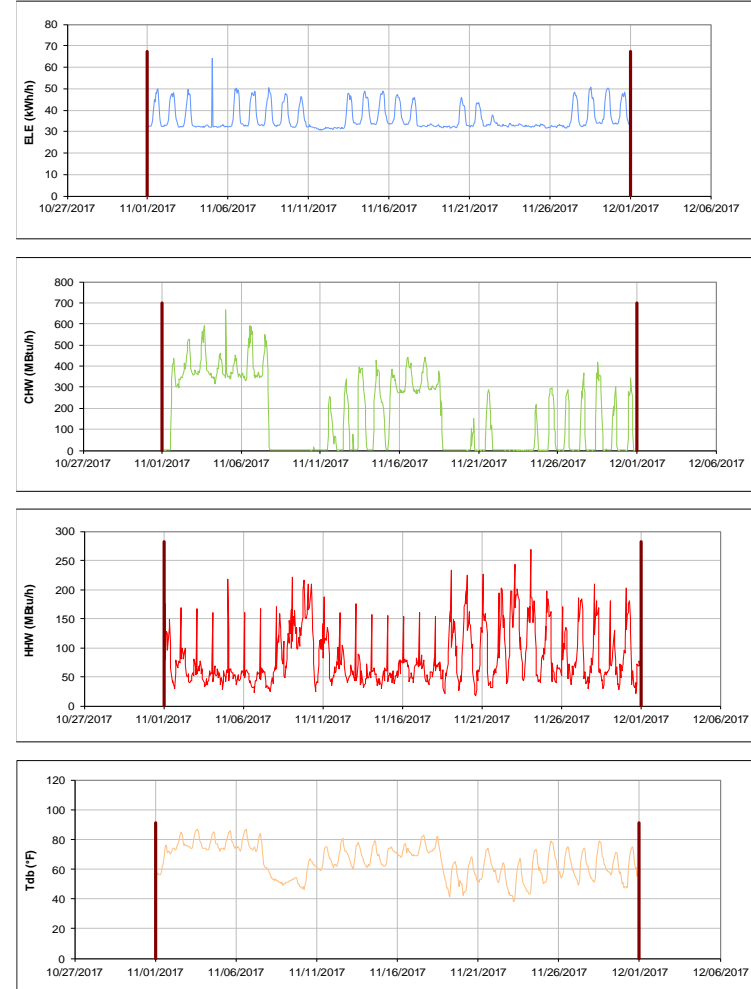
TAMU / BLDG #: 0420

Figure III-48 Hourly Whole Building Electricity, Chilled Water, and Hot Water Consumption for Milner Hall during the Month of November 2017 and the Corresponding Hourly Outdoor Dry Bulb Temperature for College Station, TX

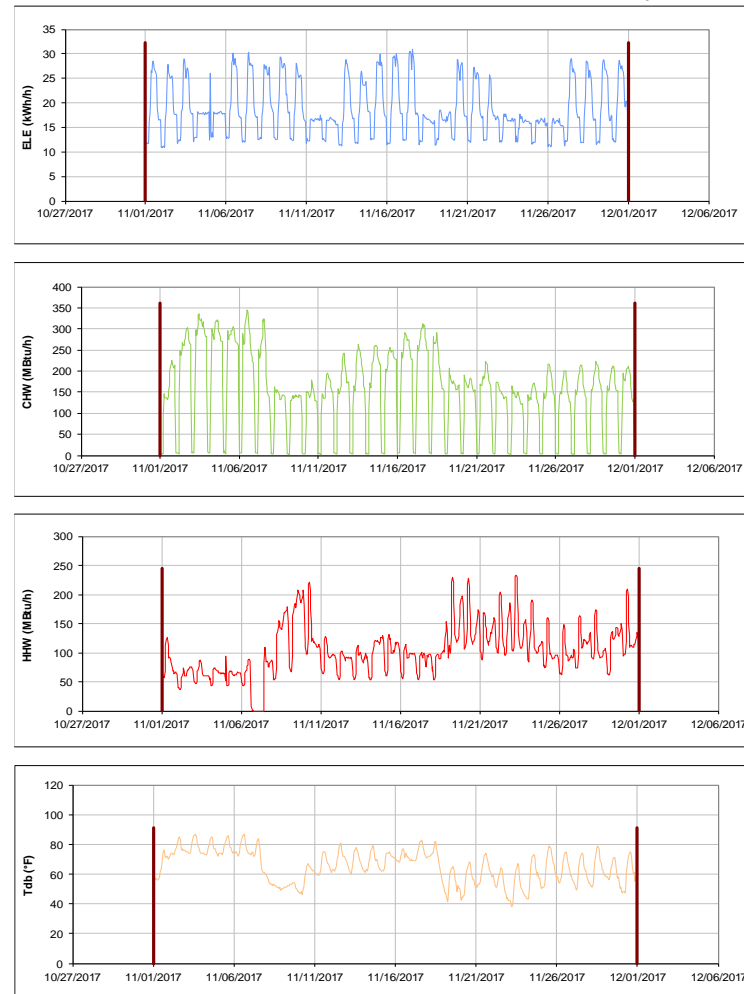
TAMU / BLDG #: 0424

Figure III-50 Hourly Whole Building Electricity, Chilled Water, and Hot Water Consumption for Hotard Hall during the Month of November 2017 and the Corresponding Hourly Outdoor Dry Bulb Temperature for College Station, TX

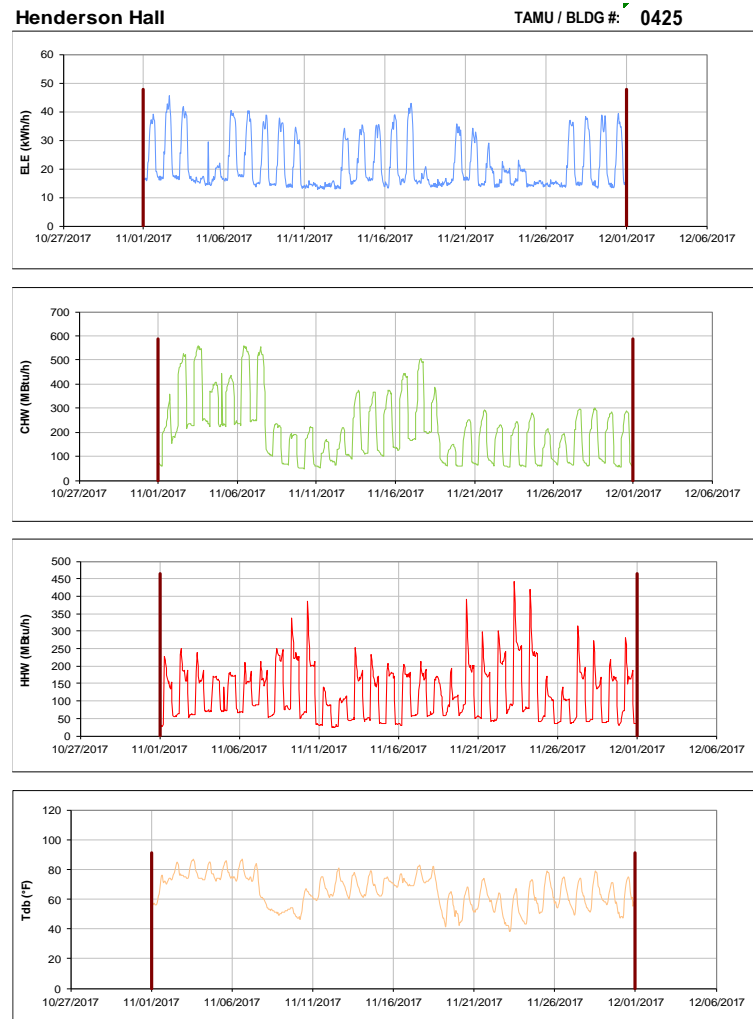
Figure III-51 Hourly Whole Building Electricity, Chilled Water, and Hot Water Consumption for Henderson Hall during the Month of November 2017 and the Corresponding Hourly Outdoor Dry Bulb Temperature for College Station, TX

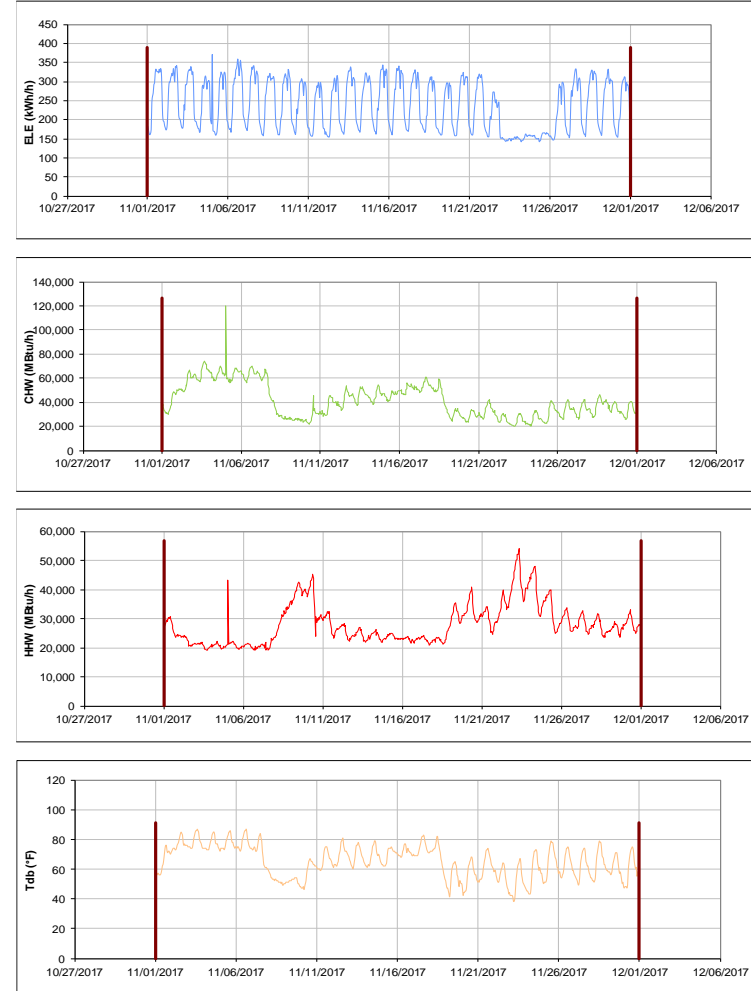
TAMU / BLDG #: 1440-0441

Figure III-56 Hourly Whole Building Electricity, Chilled Water, and Hot Water Consumption for Commons Krueger during the Month of November 2017 and the Corresponding Hourly Outdoor Dry Bulb Temperature for College Station, TX

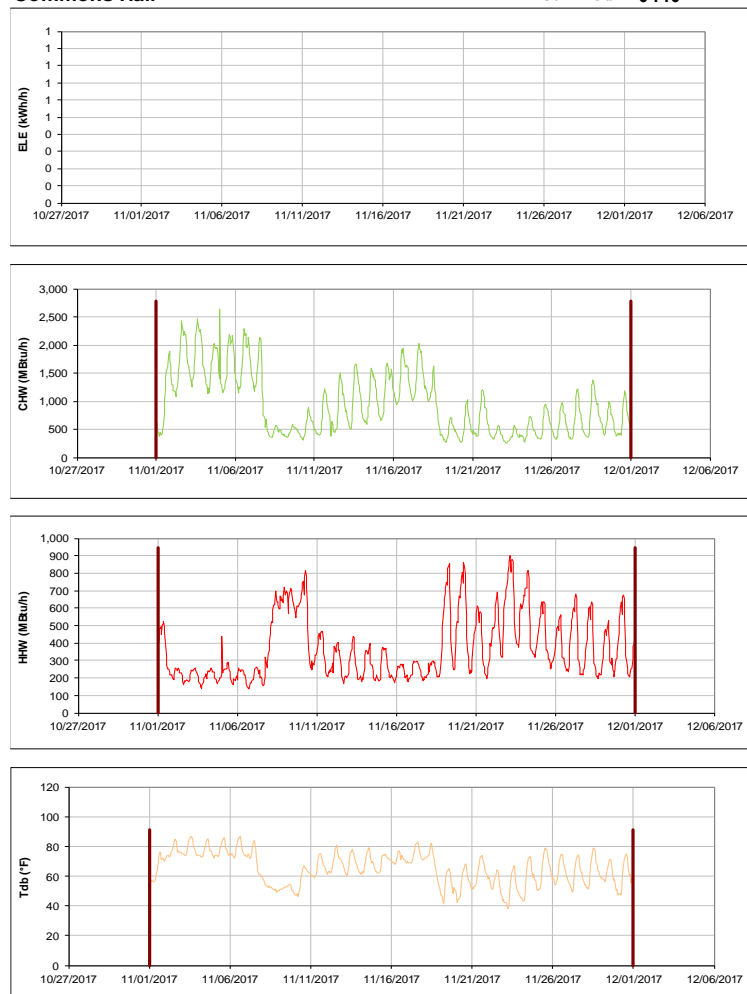
TAMU / BLDG #: 0440

Figure III-57 Hourly Whole Building Electricity, Chilled Water, and Hot Water Consumption for Commons Hall during the Month of November 2017 and the Corresponding Hourly Outdoor Dry Bulb Temperature for College Station, TX

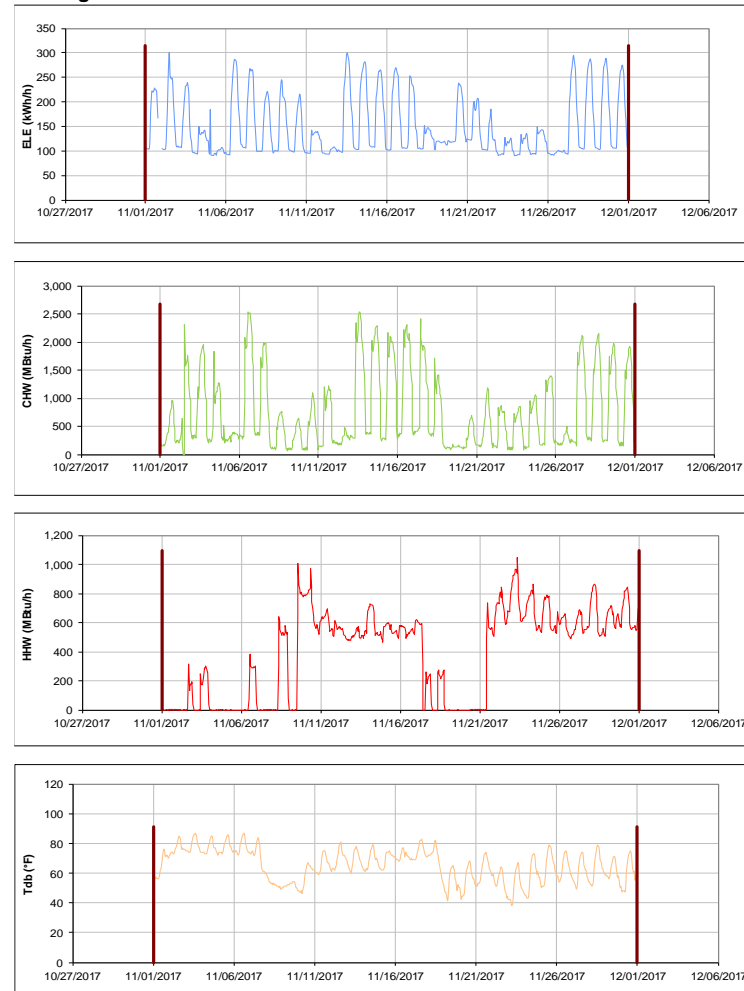
TAMU / BLDG #: 0435

Figure III-62 Hourly Whole Building Electricity, Chilled Water, and Hot Water Consumption for Harrington Education Center Office Tower during the Month of November 2017 and the Corresponding Hourly Outdoor Dry Bulb Temperature for College Station, TX

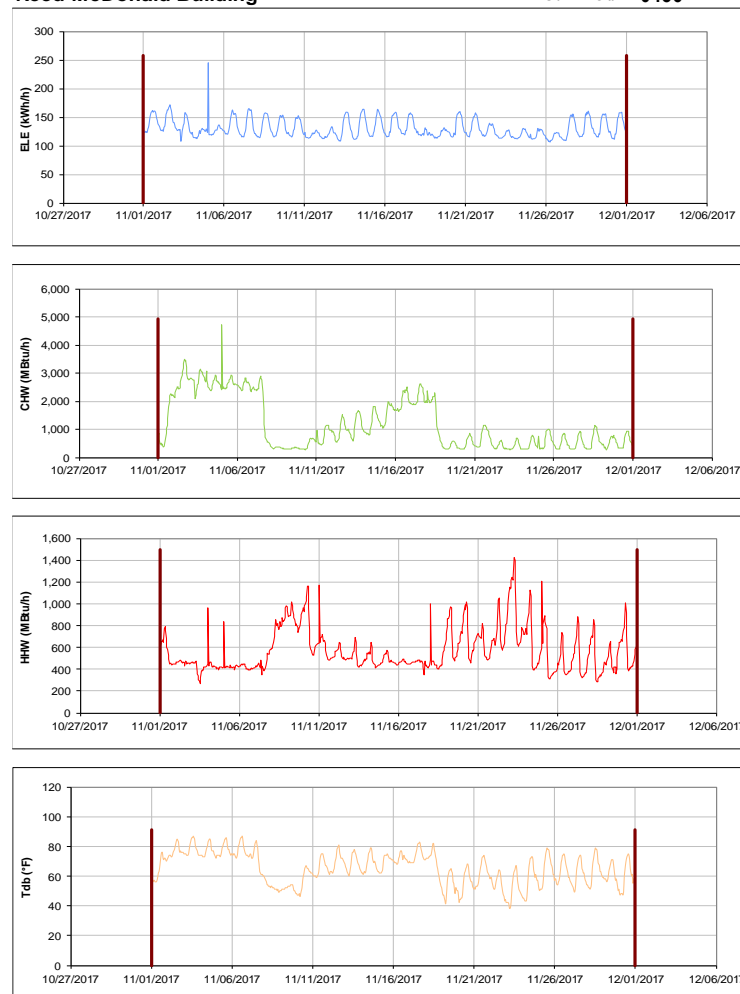
TAMU / BLDG #: 0436

Figure III-64 Hourly Whole Building Electricity, Chilled Water, and Hot Water Consumption for Reed-McDonald Building during the Month of November 2017 and the Corresponding Hourly Outdoor Dry Bulb Temperature for College Station, TX

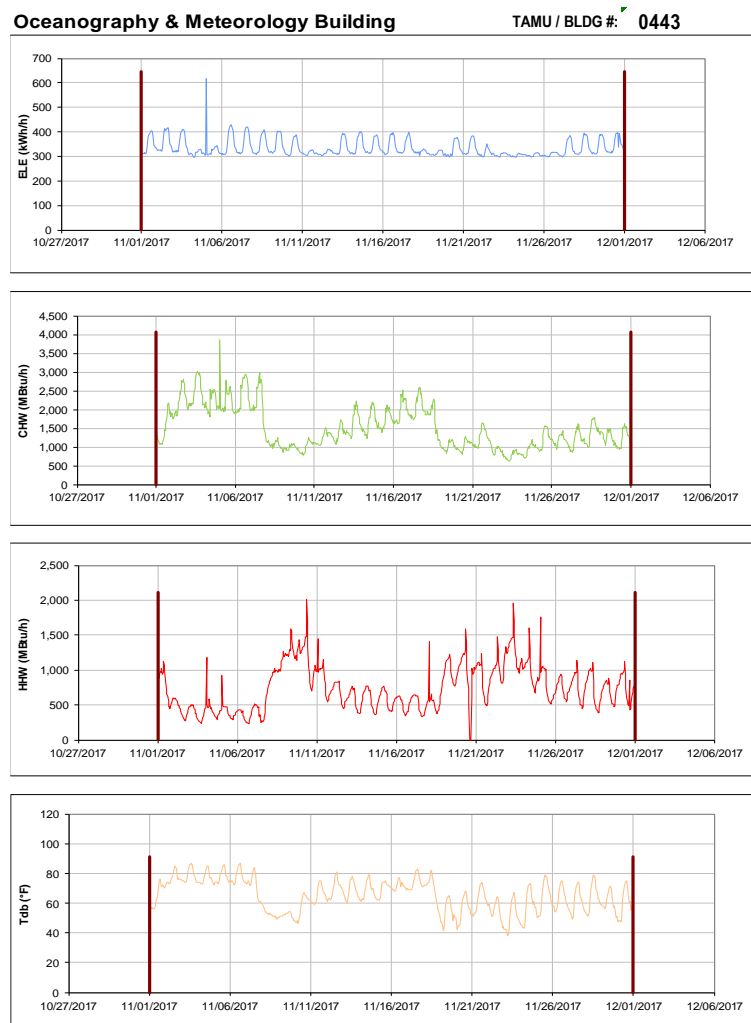
Figure III-67 Hourly Whole Building Electricity, Chilled Water, and Hot Water Consumption for Oceanography & Meteorology Building during the Month of November 2017 and the Corresponding Hourly Outdoor Dry Bulb Temperature for College Station, TX

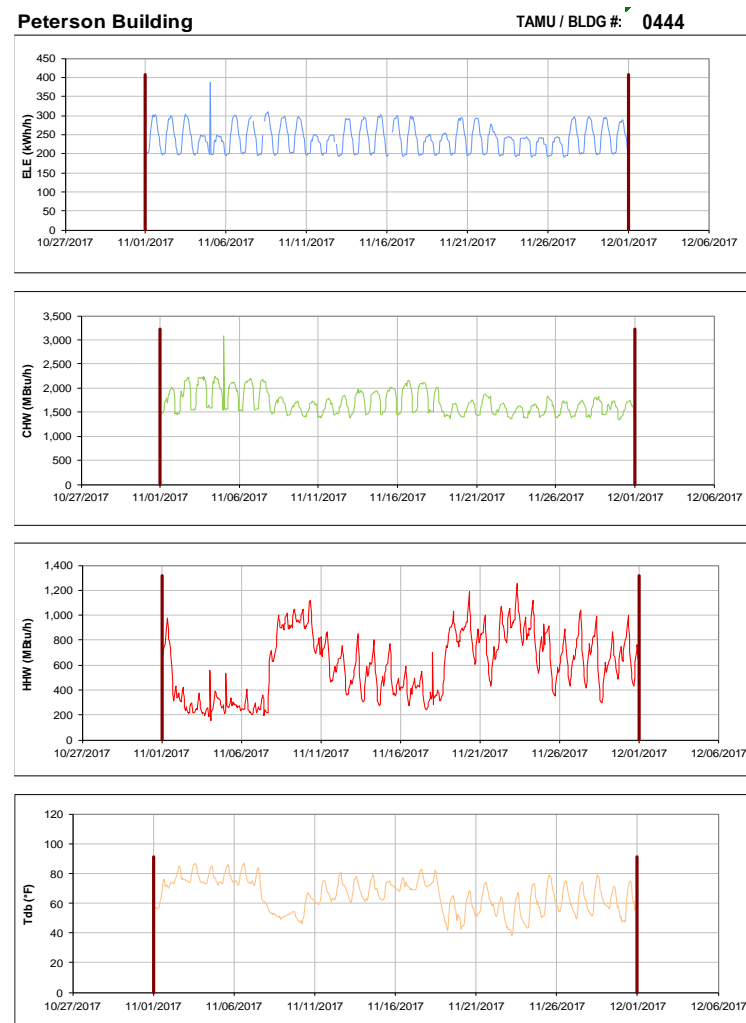
Figure III-68 Hourly Whole Building Electricity, Chilled Water, and Hot Water Consumption for Peterson Building during the Month of November 2017 and the Corresponding Hourly Outdoor Dry Bulb Temperature for College Station, TX

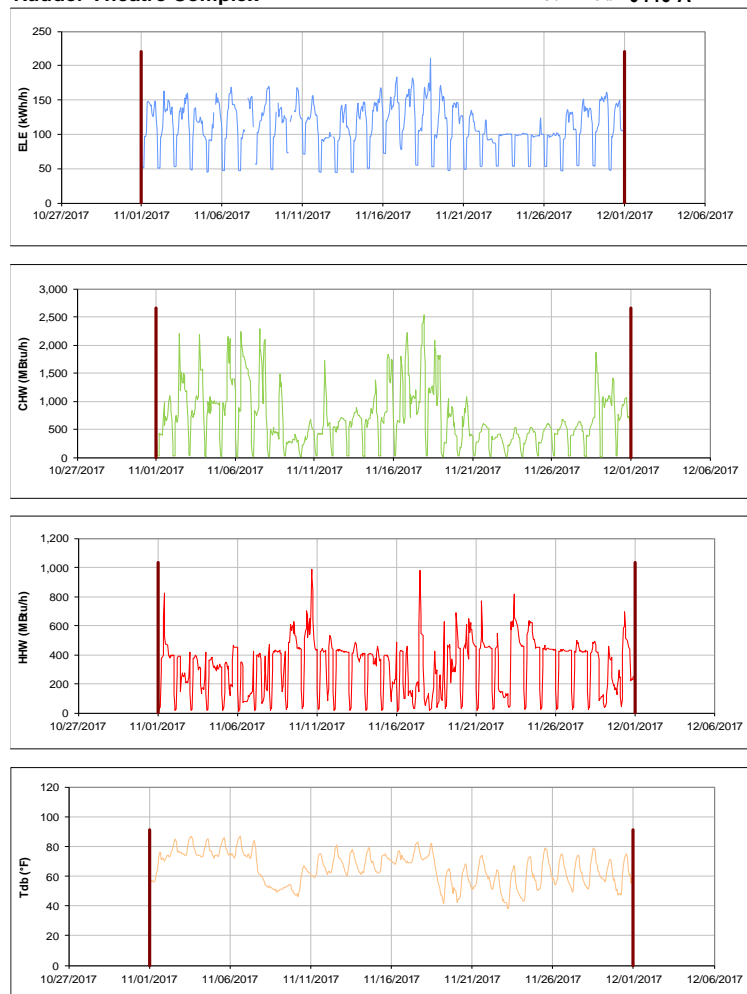
TAMU / BLDG #: 0446-A

Figure III-73 Hourly Whole Building Electricity, Chilled Water, and Hot Water Consumption for Rudder Theatre Complex during the Month of November 2017 and the Corresponding Hourly Outdoor Dry Bulb Temperature for College Station, TX

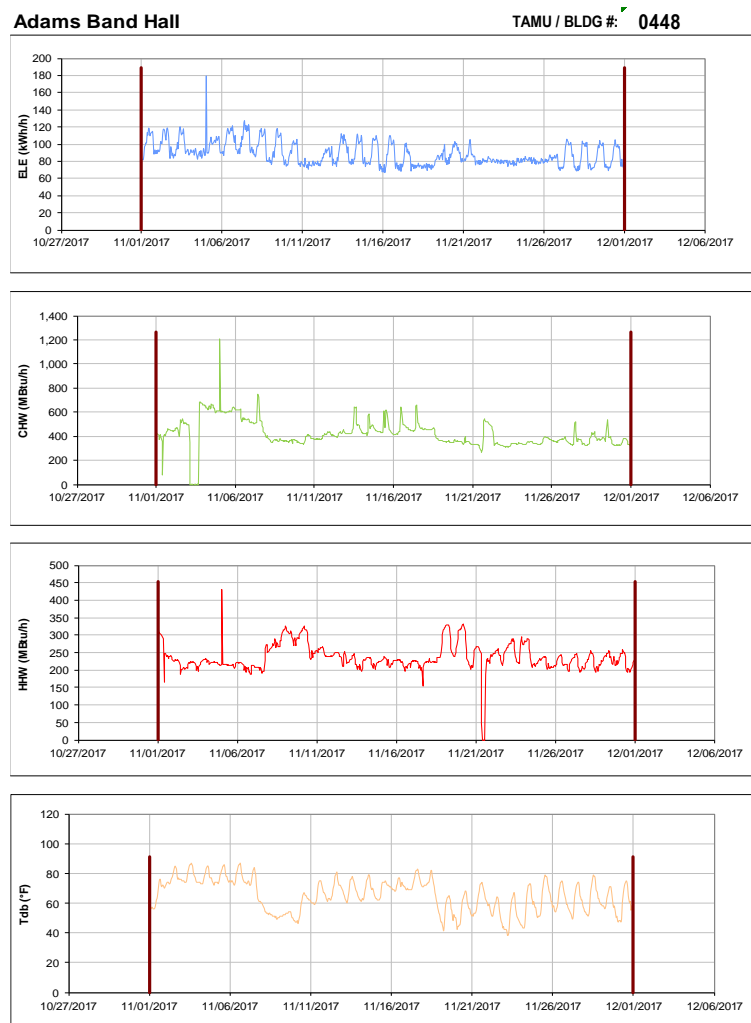
Figure III-75 Hourly Whole Building Electricity, Chilled Water, and Hot Water Consumption for Adams Band Hall during the Month of November 2017 and the Corresponding Hourly Outdoor Dry Bulb Temperature for College Station, TX

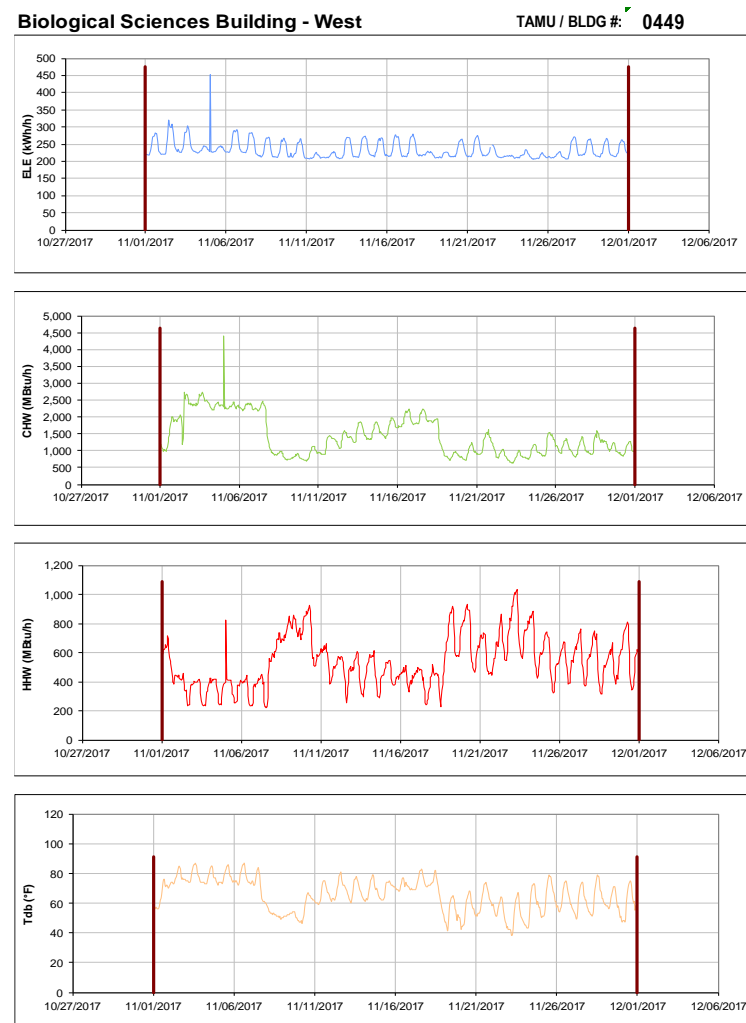
Figure III-76 Hourly Whole Building Electricity, Chilled Water, and Hot Water Consumption for Biological Sciences Building - West during the Month of November 2017 and the Corresponding Hourly Outdoor Dry Bulb Temperature for College Station, TX

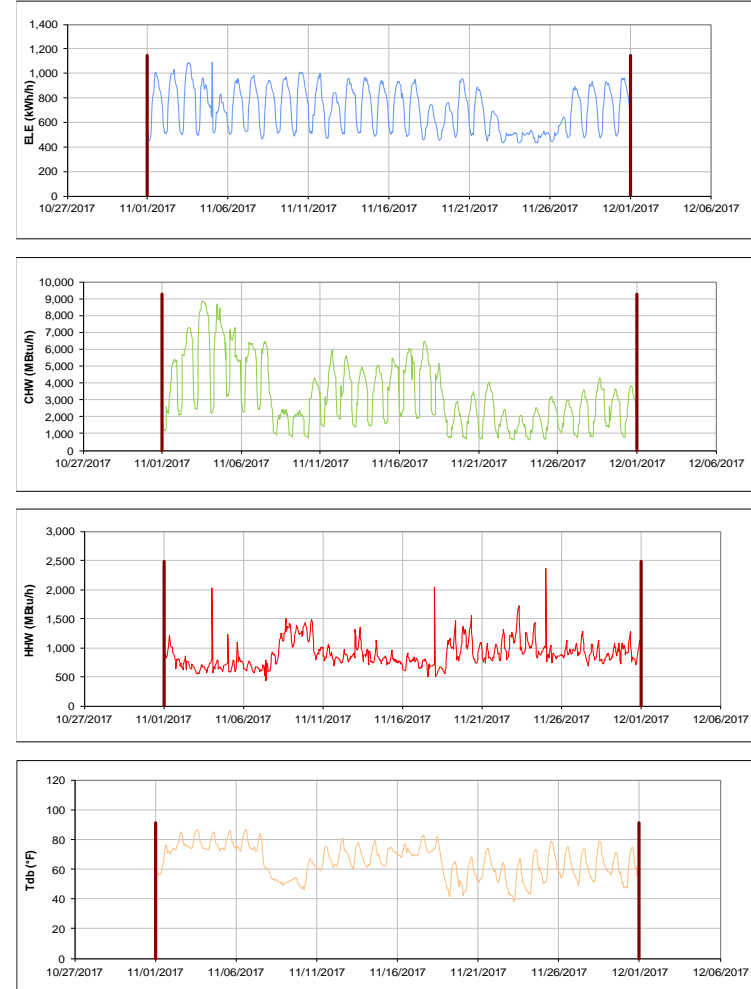
TAMU / BLDG #: 0454

Figure III-78 Hourly Whole Building Electricity, Chilled Water, and Hot Water Consumption for MSC during the Month of November 2017 and the Corresponding Hourly Outdoor Dry Bulb Temperature for College Station, TX

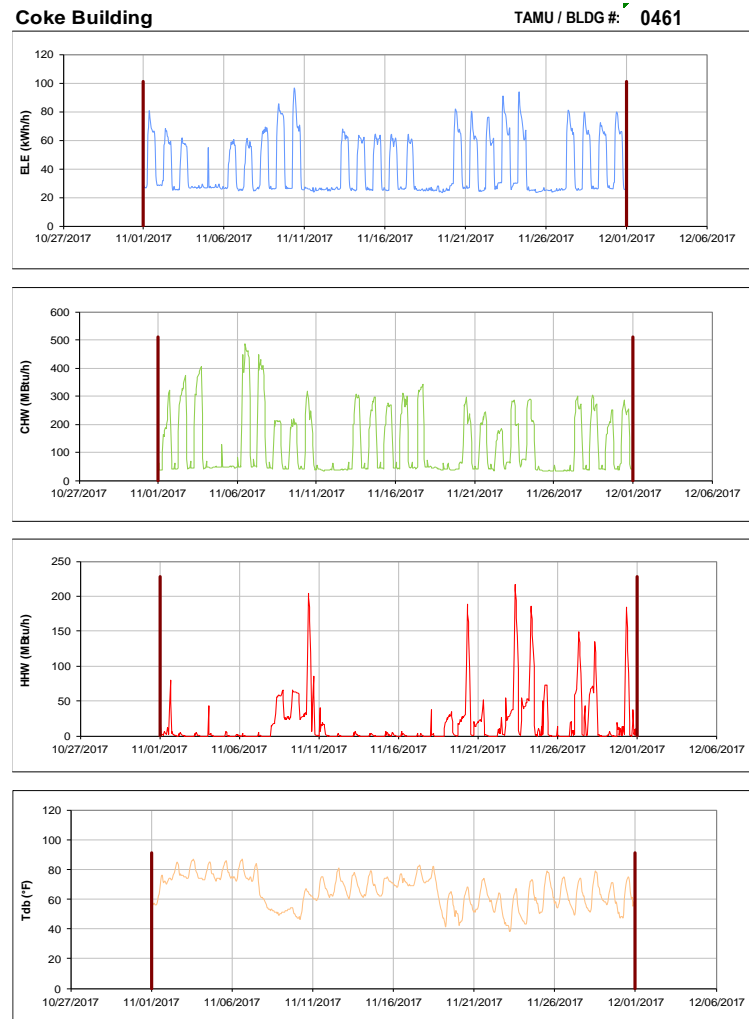
Figure III-81 Hourly Whole Building Electricity, Chilled Water, and Hot Water Consumption for Coke Building during the Month of November 2017 and the Corresponding Hourly Outdoor Dry Bulb Temperature for College Station, TX

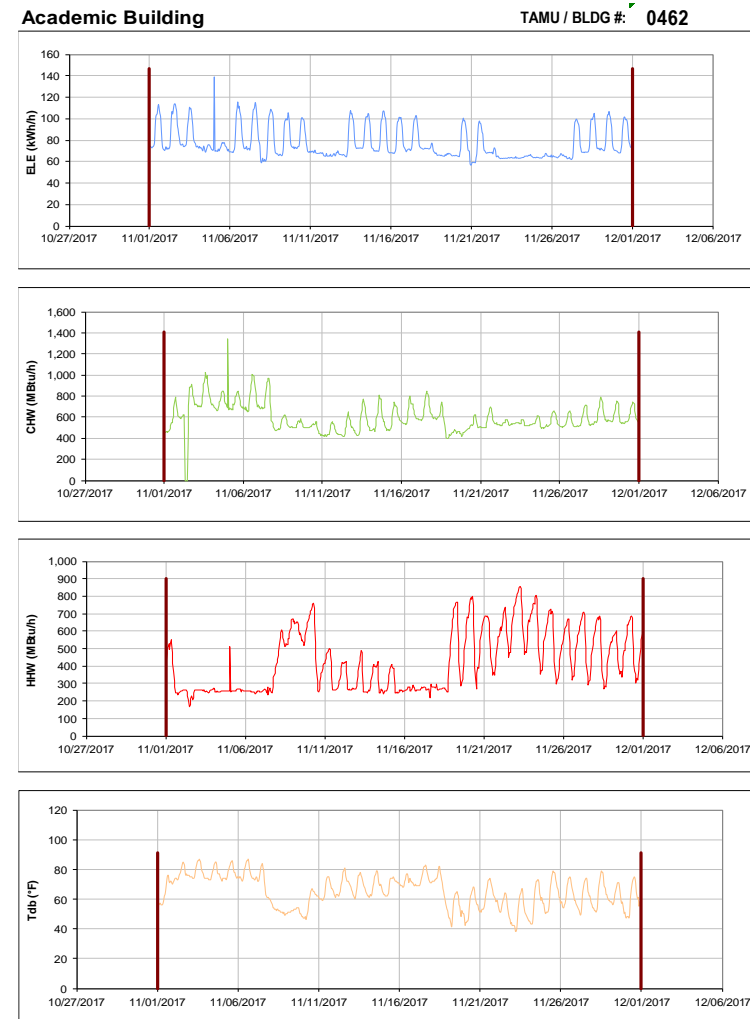
Figure III-82 Hourly Whole Building Electricity, Chilled Water, and Hot Water Consumption for Academic Building during the Month of November 2017 and the Corresponding Hourly Outdoor Dry Bulb Temperature for College Station, TX

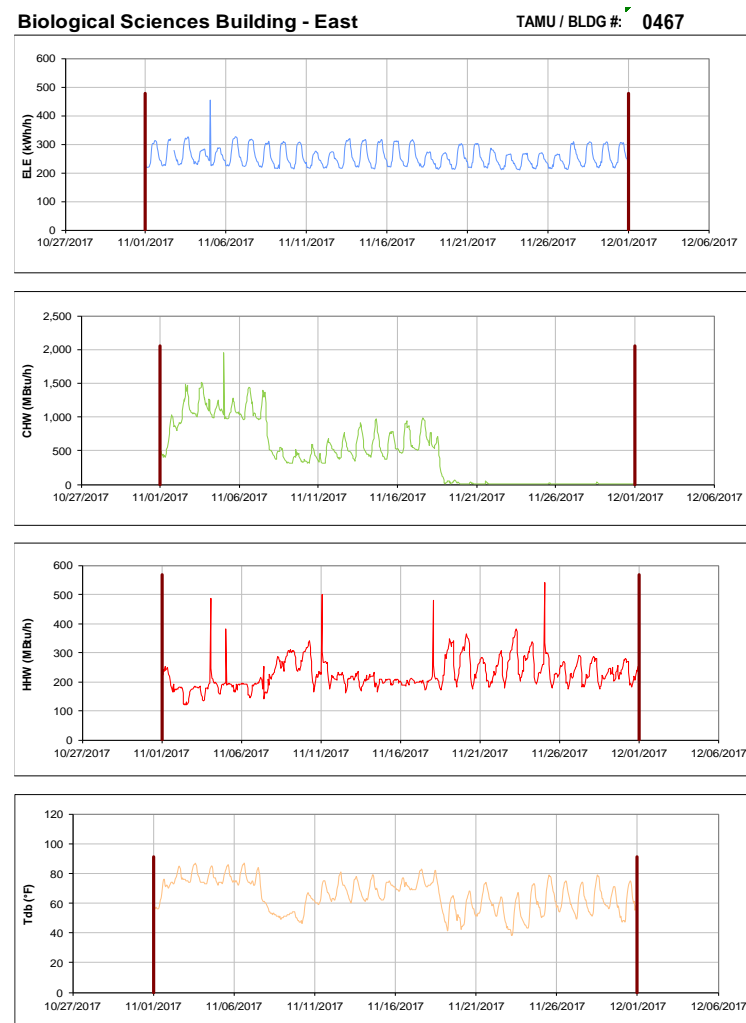
Figure III-86 Hourly Whole Building Electricity, Chilled Water, and Hot Water Consumption for Biological Sciences Building - East during the Month of November 2017 and the Corresponding Hourly Outdoor Dry Bulb Temperature for College Station, TX

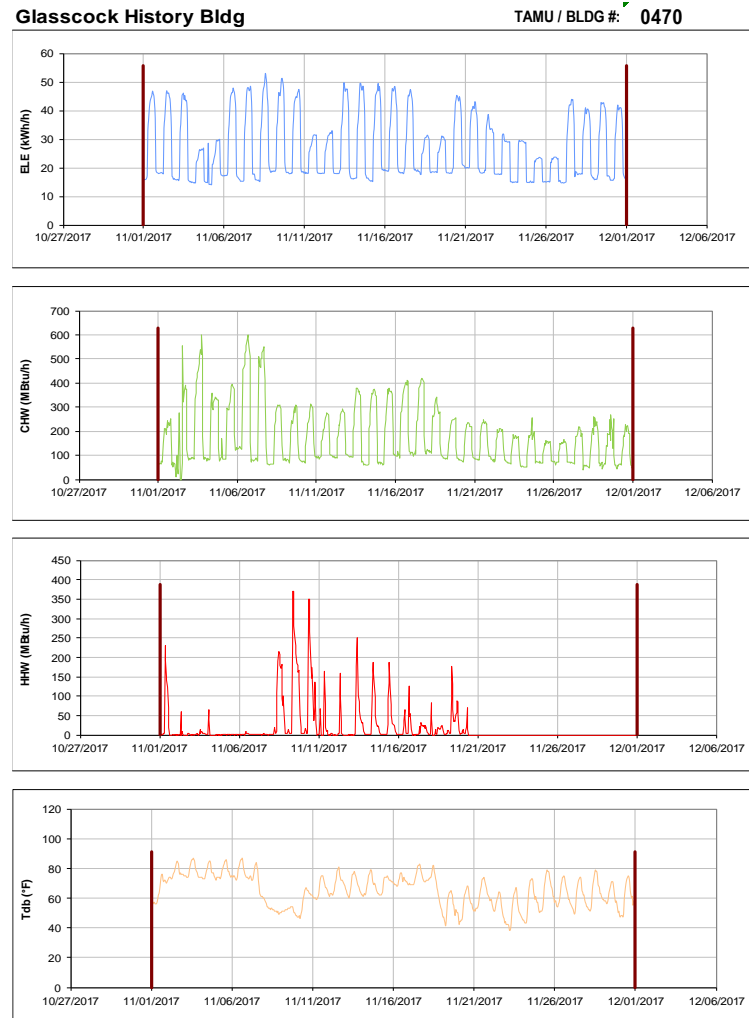
Figure III-89 Hourly Whole Building Electricity, Chilled Water, and Hot Water Consumption for Glasscock History Bldg during the Month of November 2017 and the Corresponding Hourly Outdoor Dry Bulb Temperature for College Station, TX
